**LIMITED ASBESTOS CONTAINING BUILDING
MATERIAL SURVEY

UNIVERSITY OF NORTH ALABAMA CAMPUS
LAGRANGE HALL
1660 TUNE AVENUE
FLORENCE, ALABAMA

TTSI PROJECT # 2017-1035**

Re: Limited Asbestos Containing Building Material Survey of LaGrange Hall, Located on the University of North Alabama Campus in Florence, Alabama (TTSI Project #2017-1035)

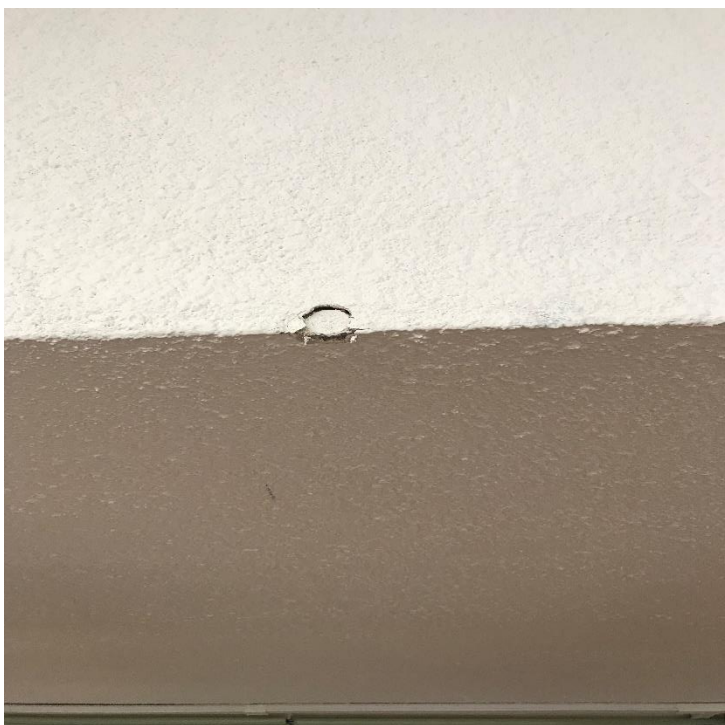
Ceiling Texture Room 107
Sample 1-4

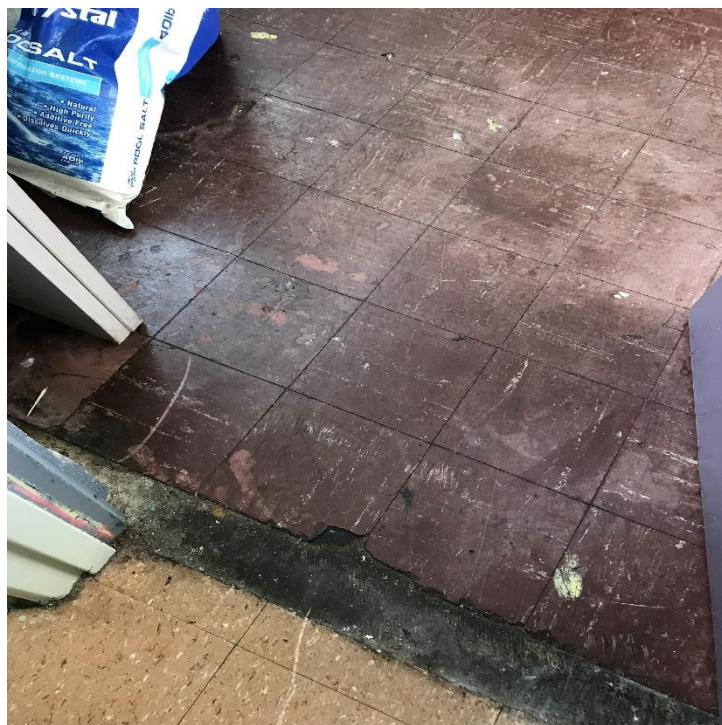
Brown 9x9 Floor Tile Room 126
Sample 1-2

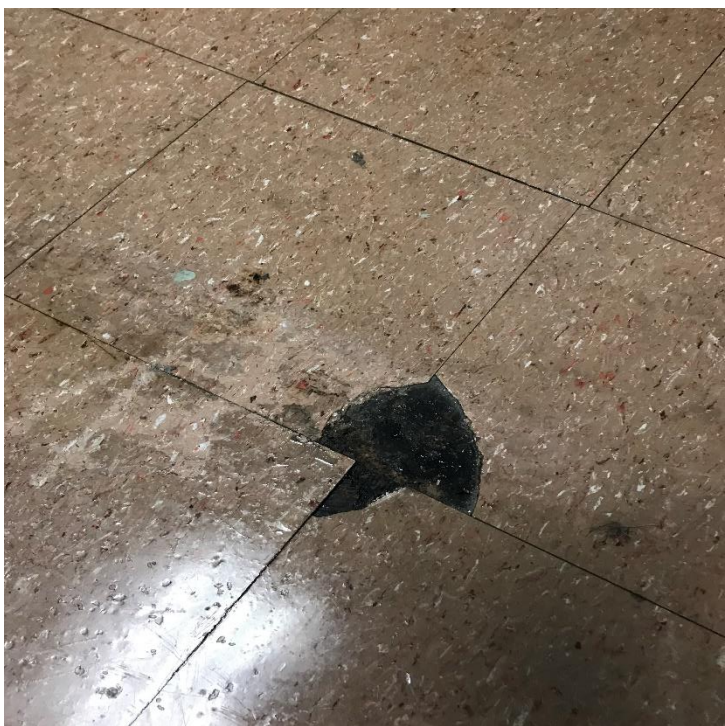
Tan Speckled 12x12 Floor Tile Room 0107
Sample 1-1

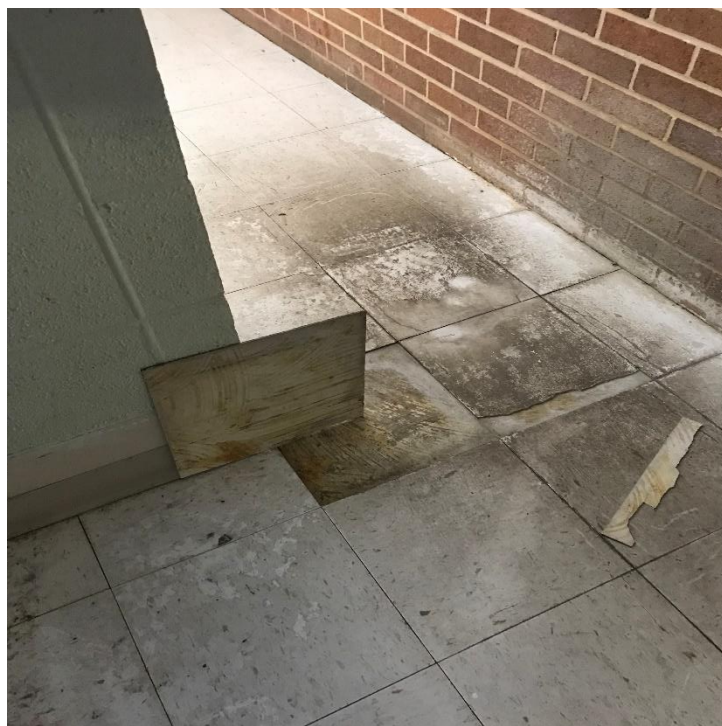
Off White Speckled 12x12 Floor Tile
Room 0110
Sample 1-3

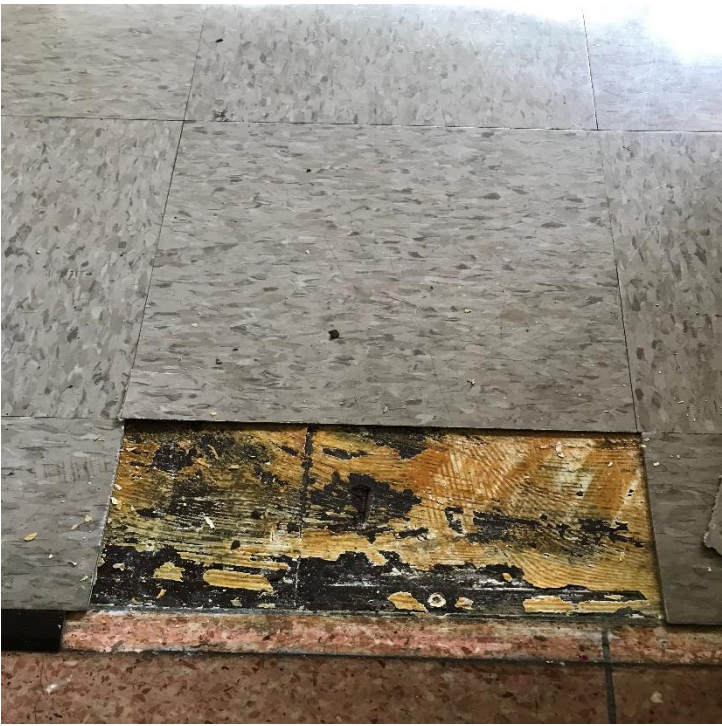
9x9 Brown Under 12x12 Room 0106

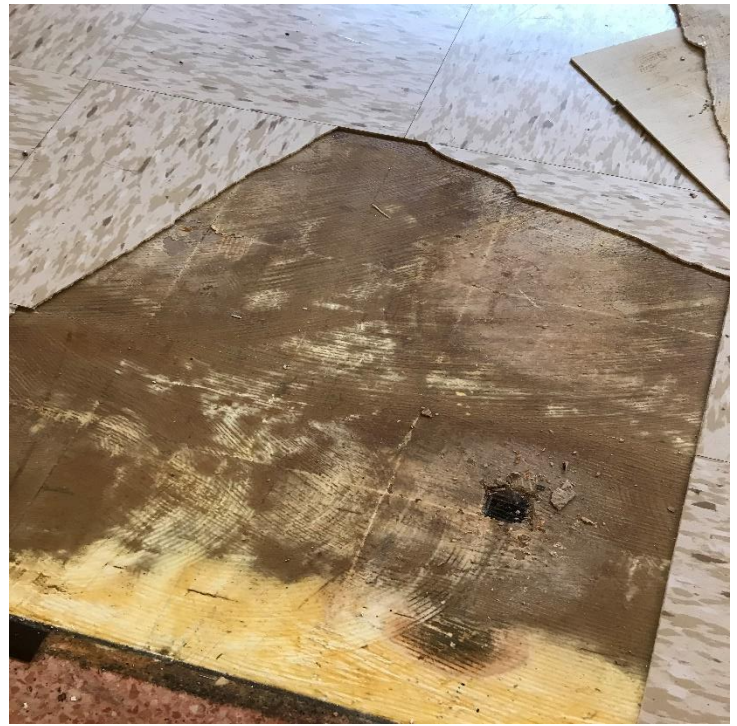
Brown 9x9 Under 12x12 Room 0111

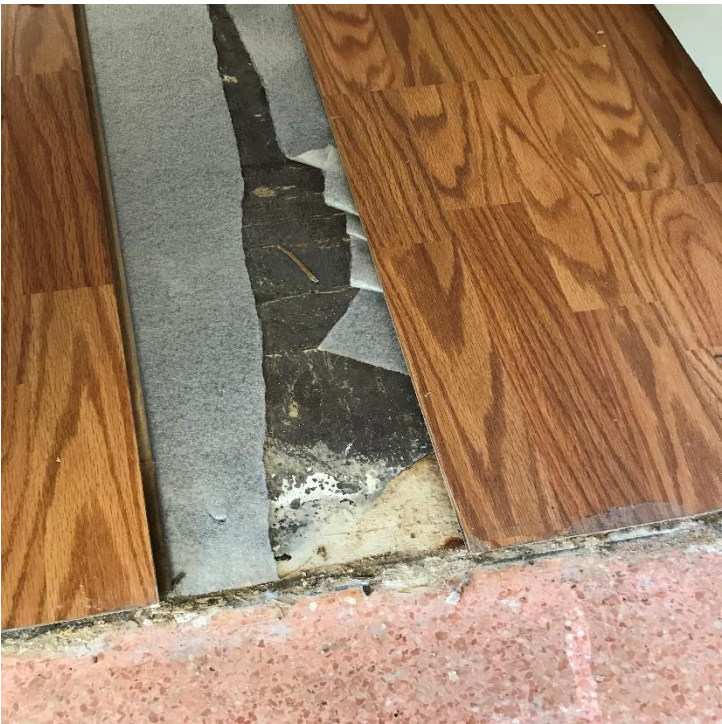
Brown 9x9 under Laminate Room 0116

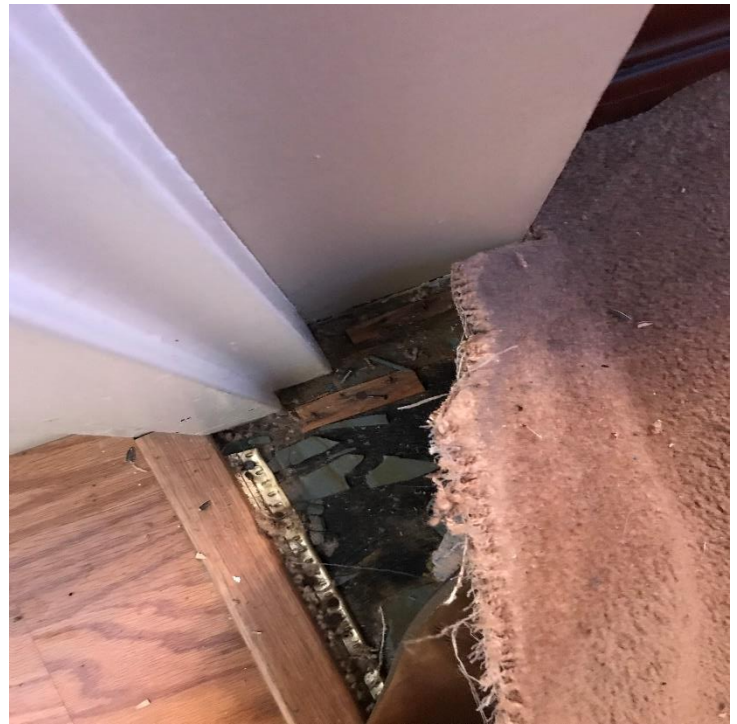
Blue 9x9 Floor Tile Under Carpet Room 0116
Sample 1-5

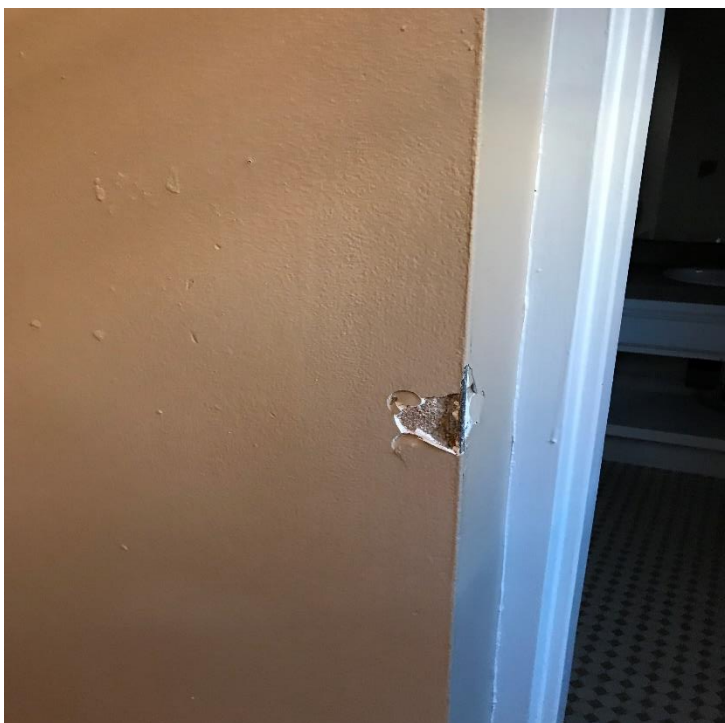
Wall Plaster Room 0116
Sample 1-6

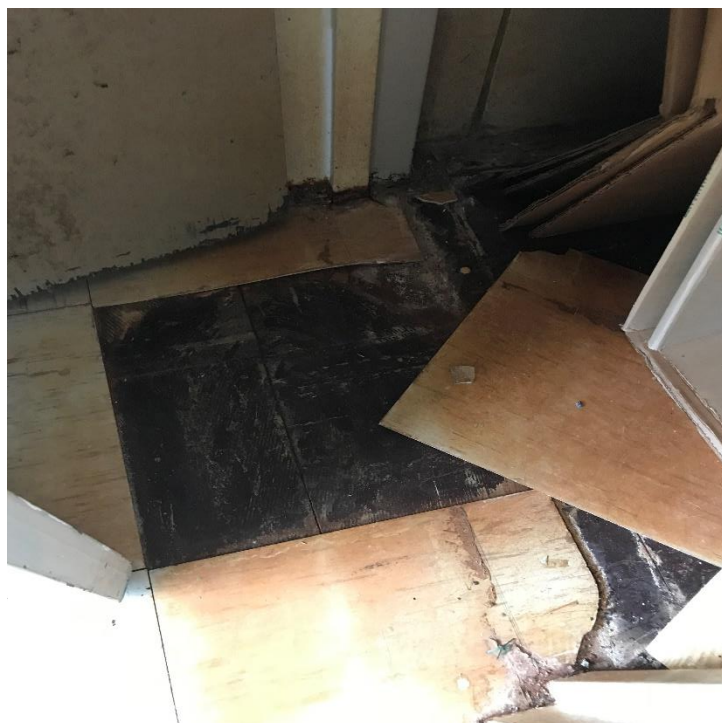
9x9 Brown Under 12x12 Room 0116

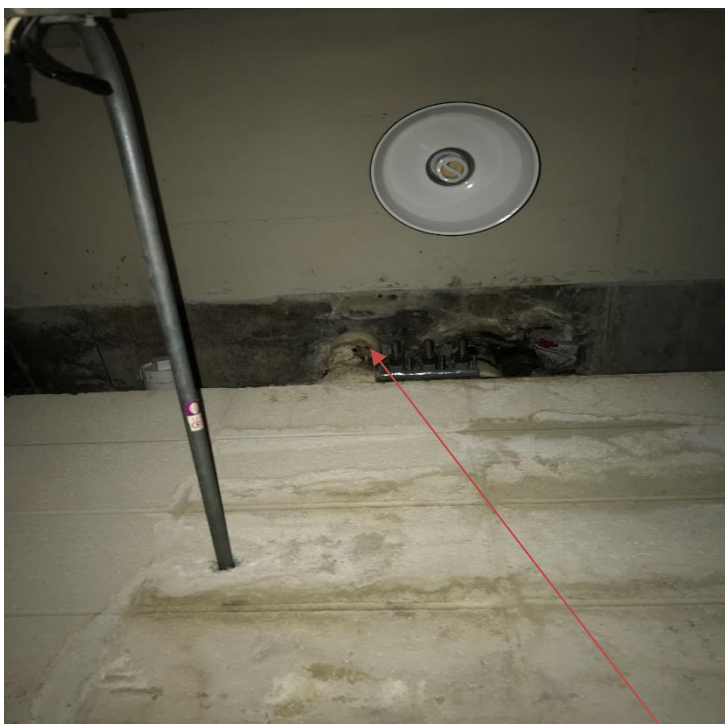
Elbow Insulation Room 0120
Sample 1-7

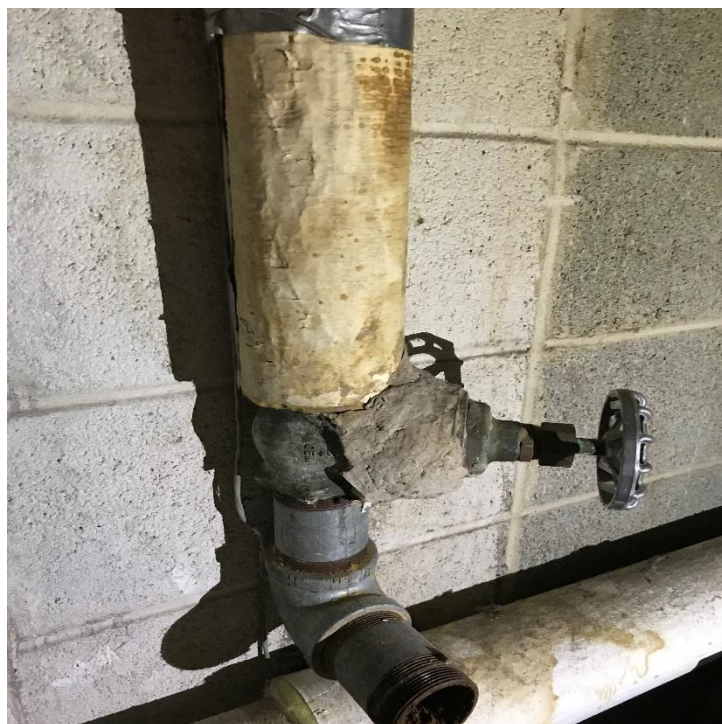
Valve insulation Room 0113
Sample 1-8

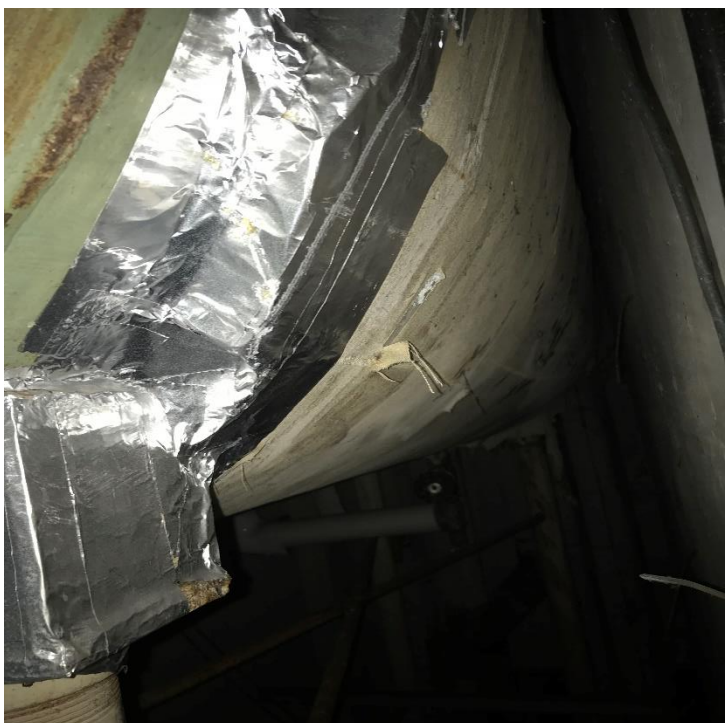
Vessel Insulation Room 0113
Sample 1-9

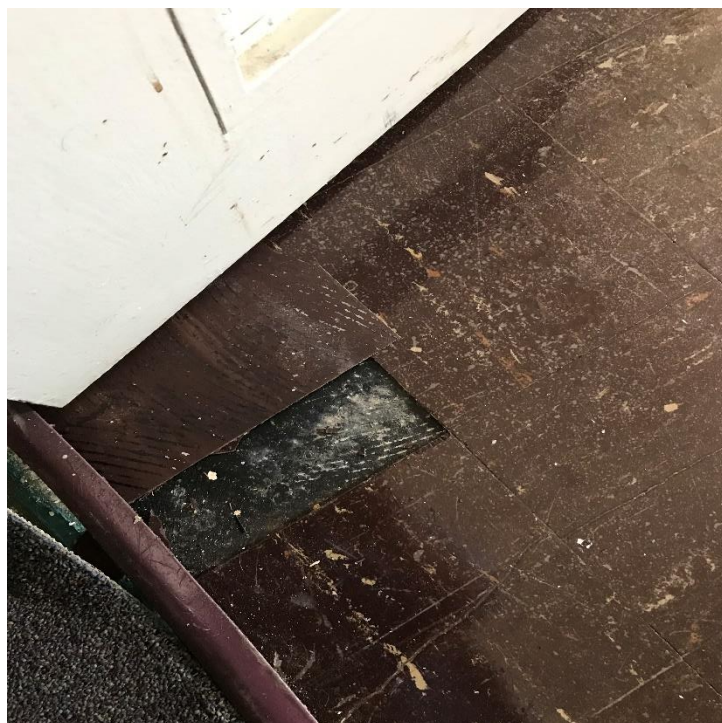
Brown 9x9 Floor Tile Room 223
Sample 2-1

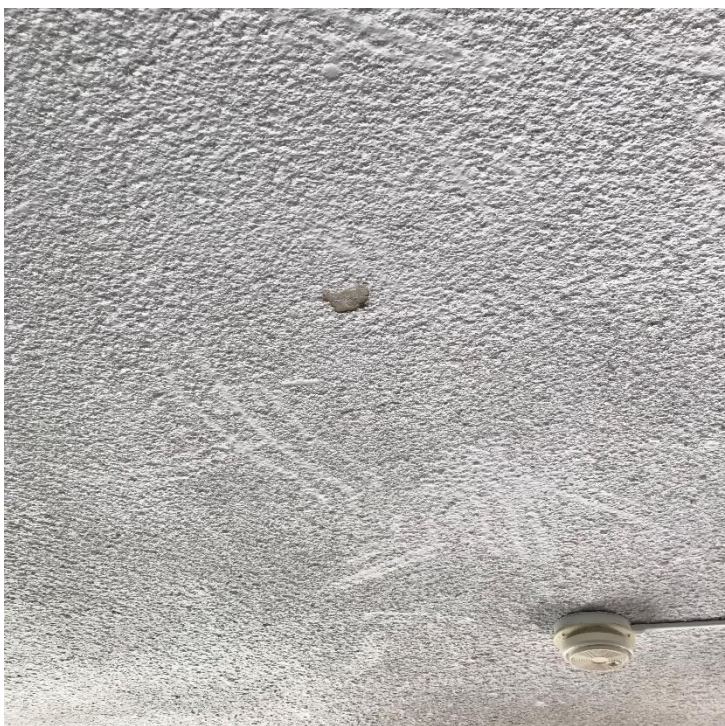
Ceiling Texture Room 0223
Sample 2-2

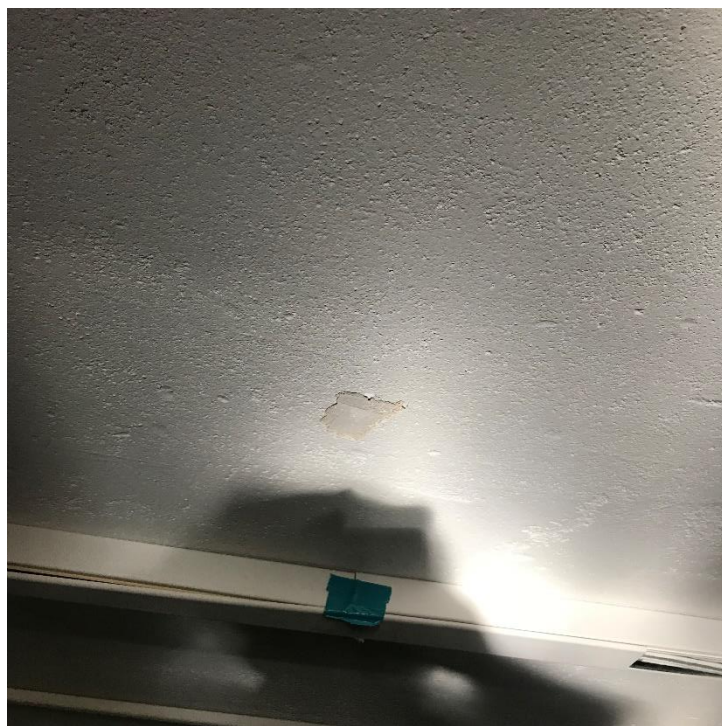
Ceiling Plaster, East Hall 0220
Sample 2-3

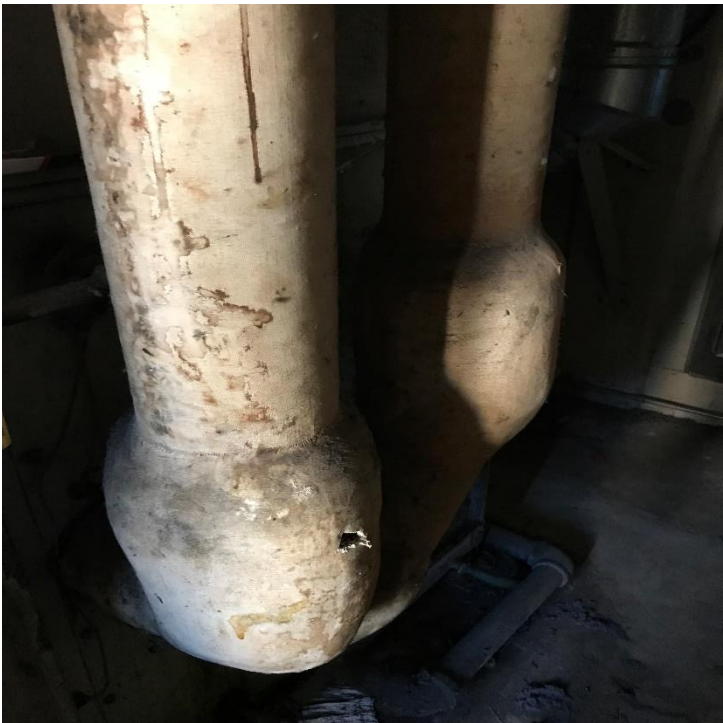
TSI Elbow Room 0229
Sample 2-4

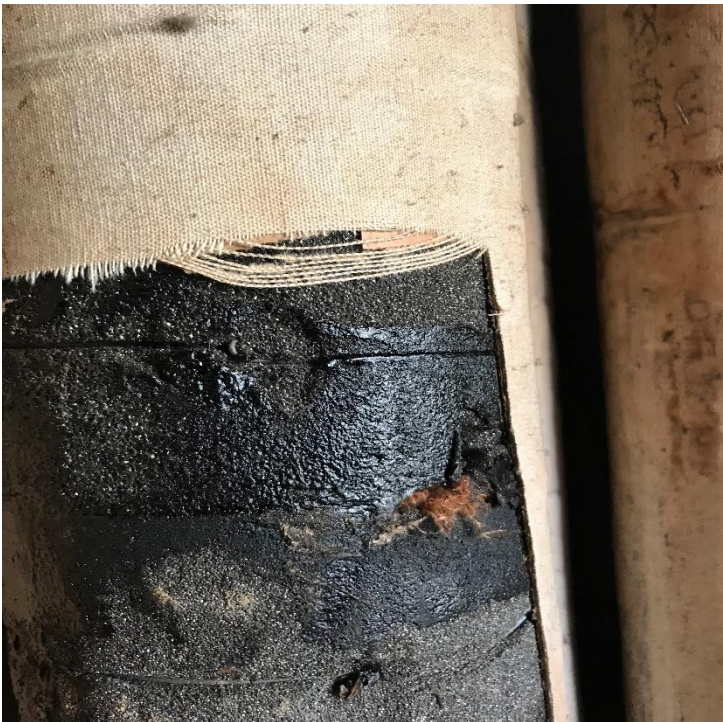
Black Mastic Under Wrap Room 0229
Sample 2-6

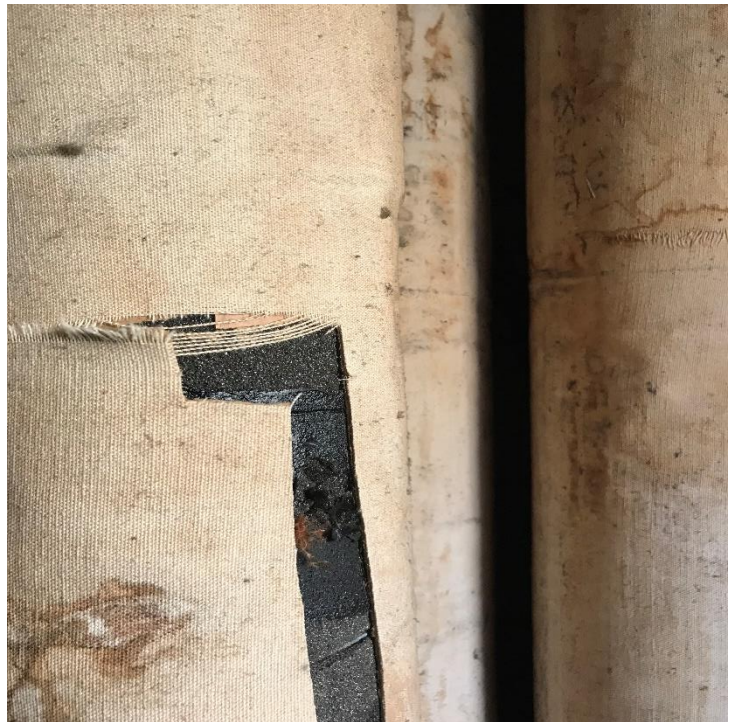
Black Mastic Under Wrap Room 0229

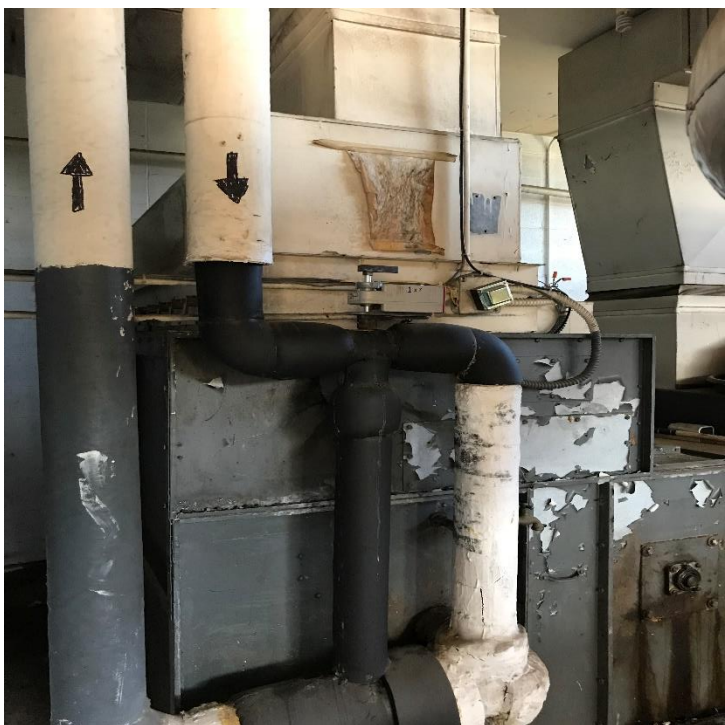
TSI Room 0125

Sample Number	Location	Description	Asbestos	Approximate Quantity	Physical Condition	Abatement / Removal Date
LaGrange Hall – First Floor Continued						
1-11 Layer 1 1-12 Layer 3	Mechanical Room 0125 Northeast Corner and Pipe Chase	Gray TSI Pipe Insulation & Black Mastic	3% Chrysotile	Approx. 375 Linear Feet	Good

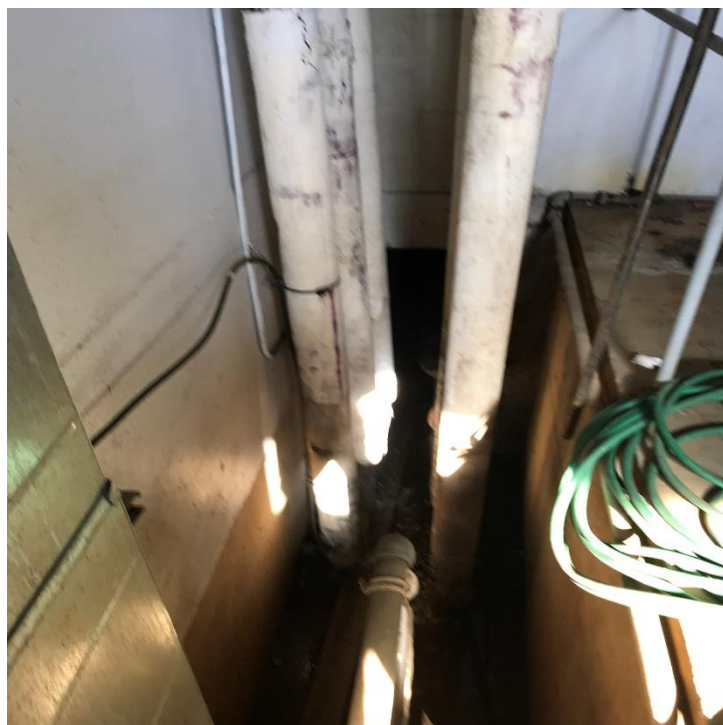
Pipes Entering Room 0125 From Room 0113

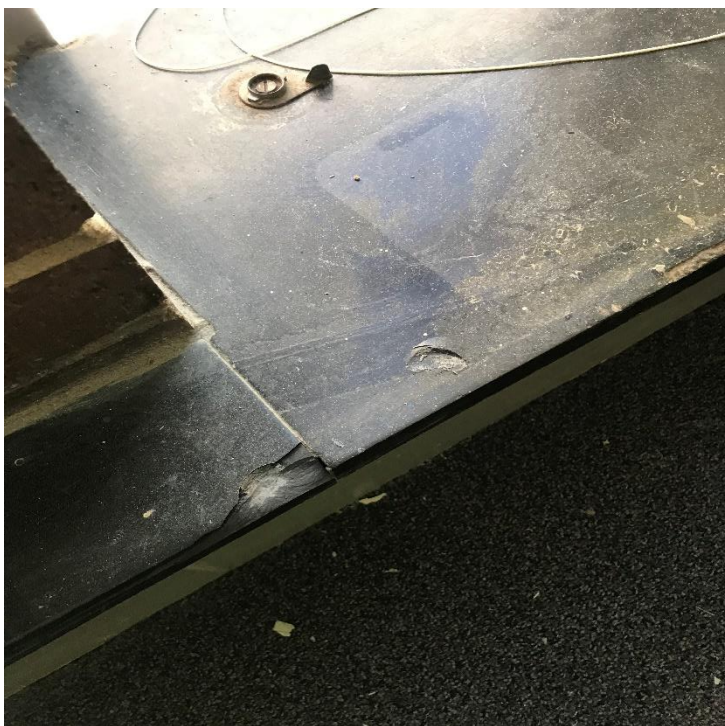
Black Slate Window Ledge Room 0409
Sample 4-12

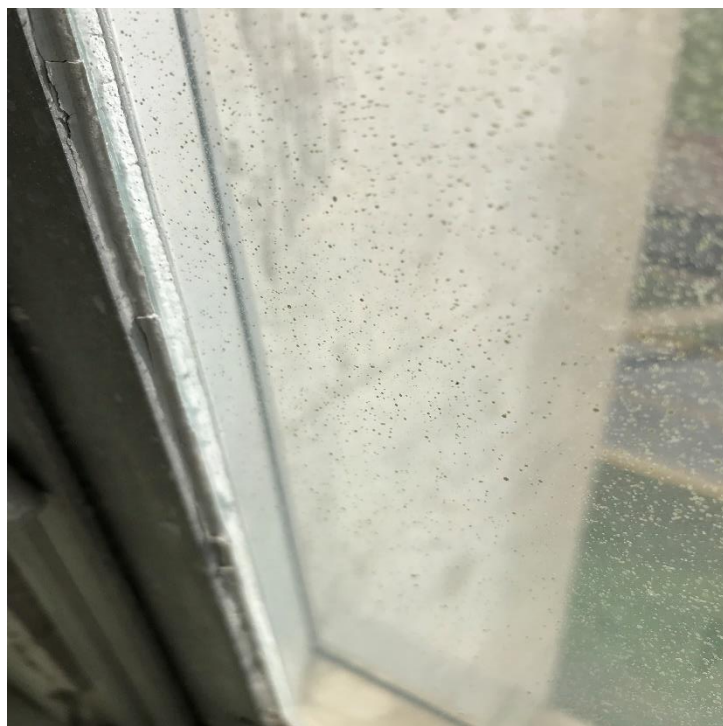
Interior Window Caulk Room 0423
Sample 4-4

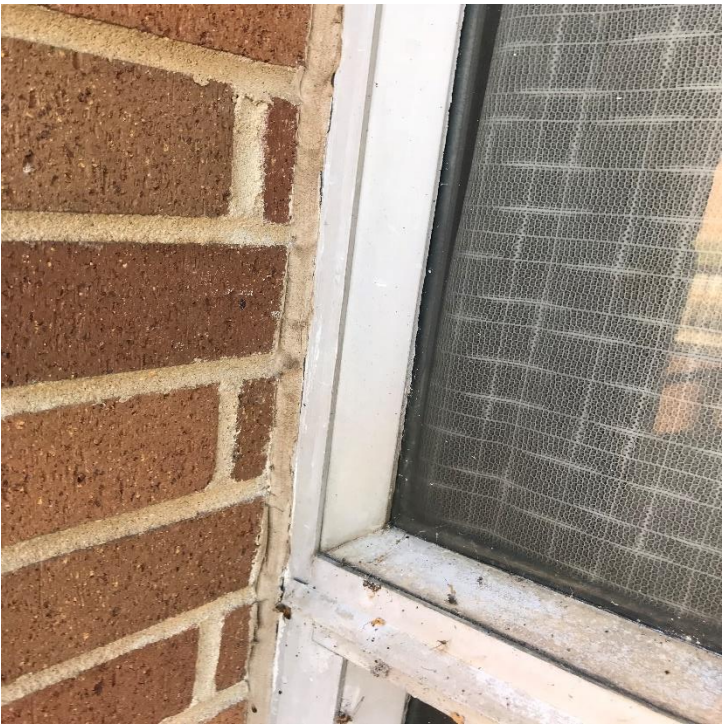
Exterior Window Caulk Northeast
Sample 2-11

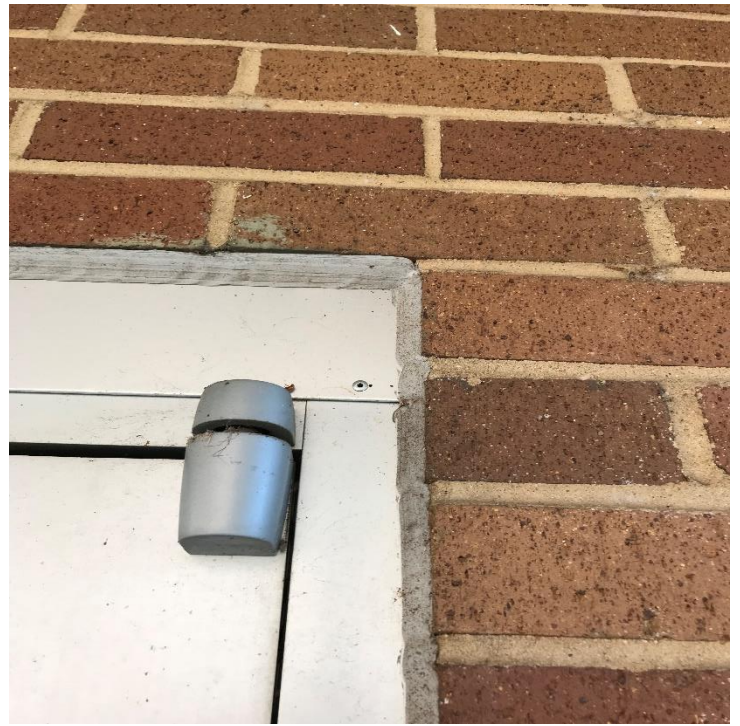
North Exterior Door Caulk
Sample 2-9

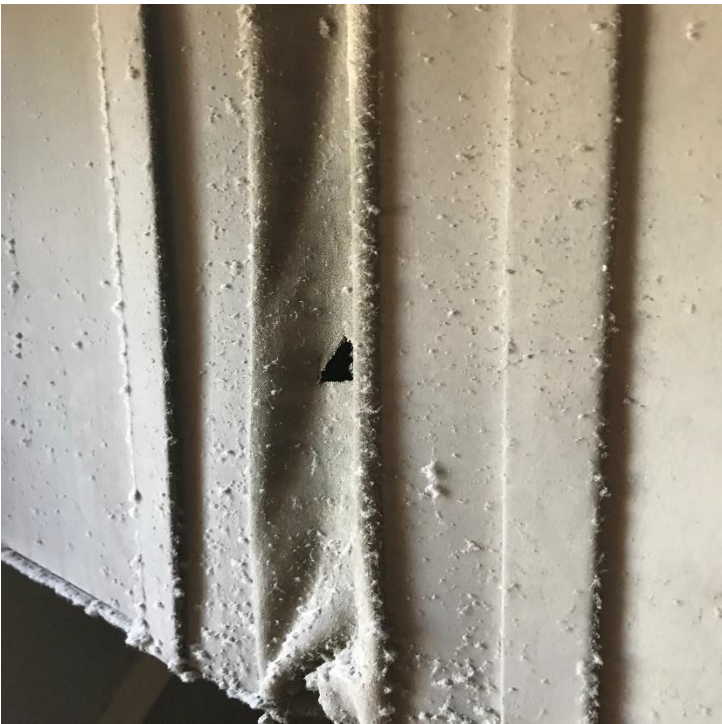
HVAC Vibration Dampener Room 0427
Sample 4-10

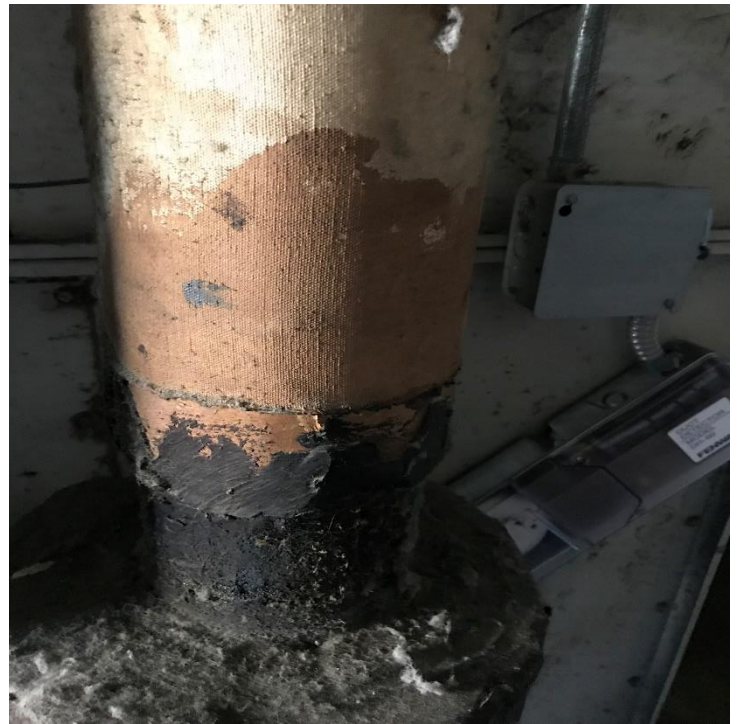
TSI and Black Mastic Room 0427
Sample 4-5

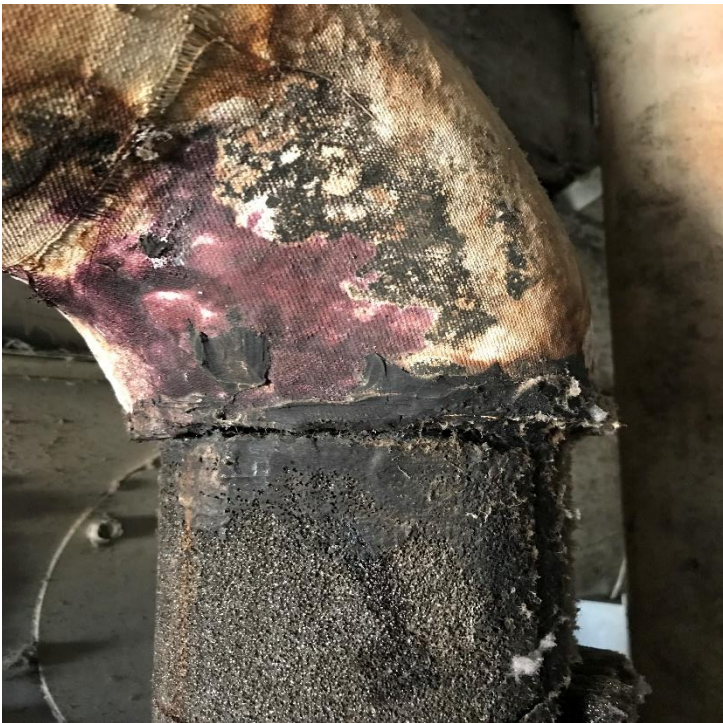
TSI Elbow Room 0427
Sample 4-6

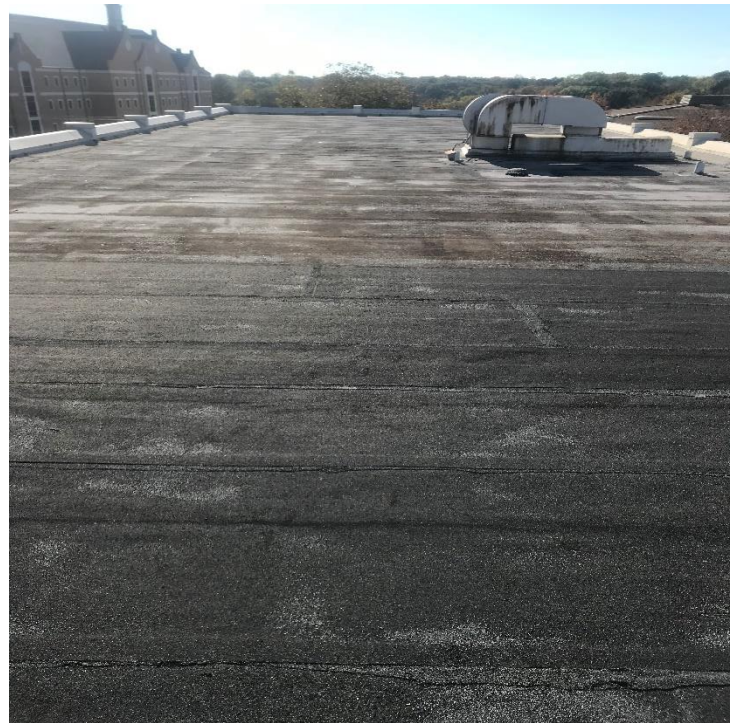
Roof
General Condition

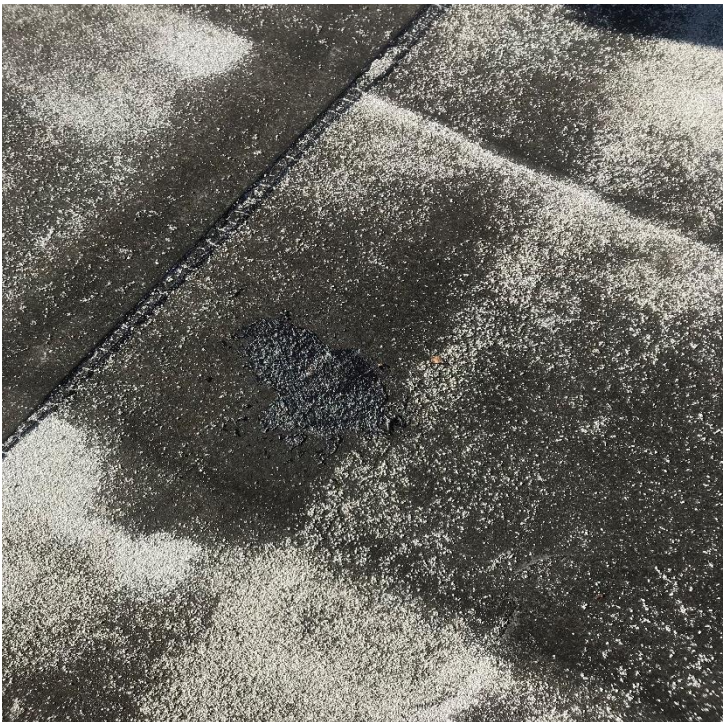
Roof Core Sample, West Field Sample R-1

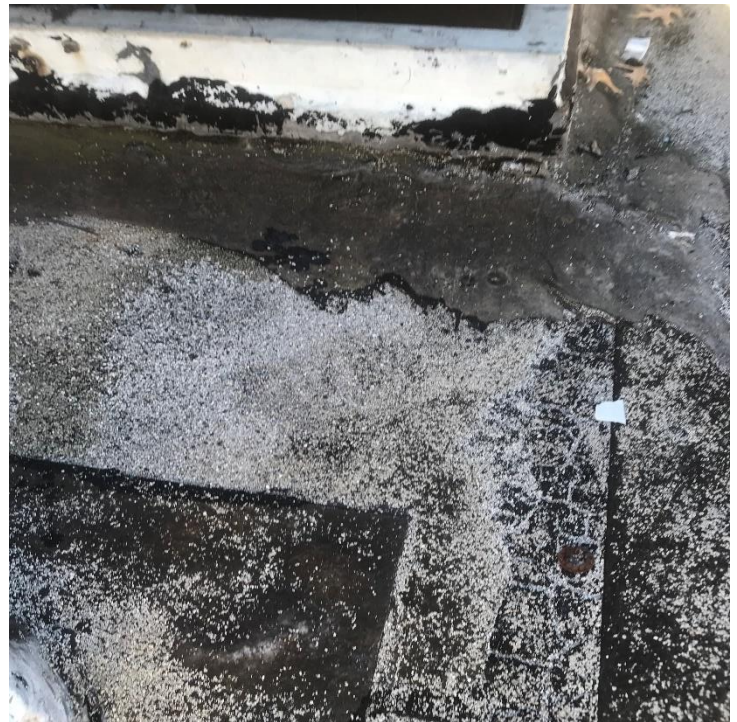
Roof Flashing Sample, East
Sample R-3
